RICS
HomeBuyer Report

- A Introduction to the report
 - B About the inspection
 - C Overall opinion and summary of the condition ratings
 - D About the property
 - E Outside the property
 - F Inside the property
 - G Services
 - H Grounds (including shared areas for flats)
 - I Issues for your legal advisers
 - J Risks
 - K Valuation
 - L Surveyor's declaration
- What to do now
Description of the RICS HomeBuyer Service
Typical house diagram

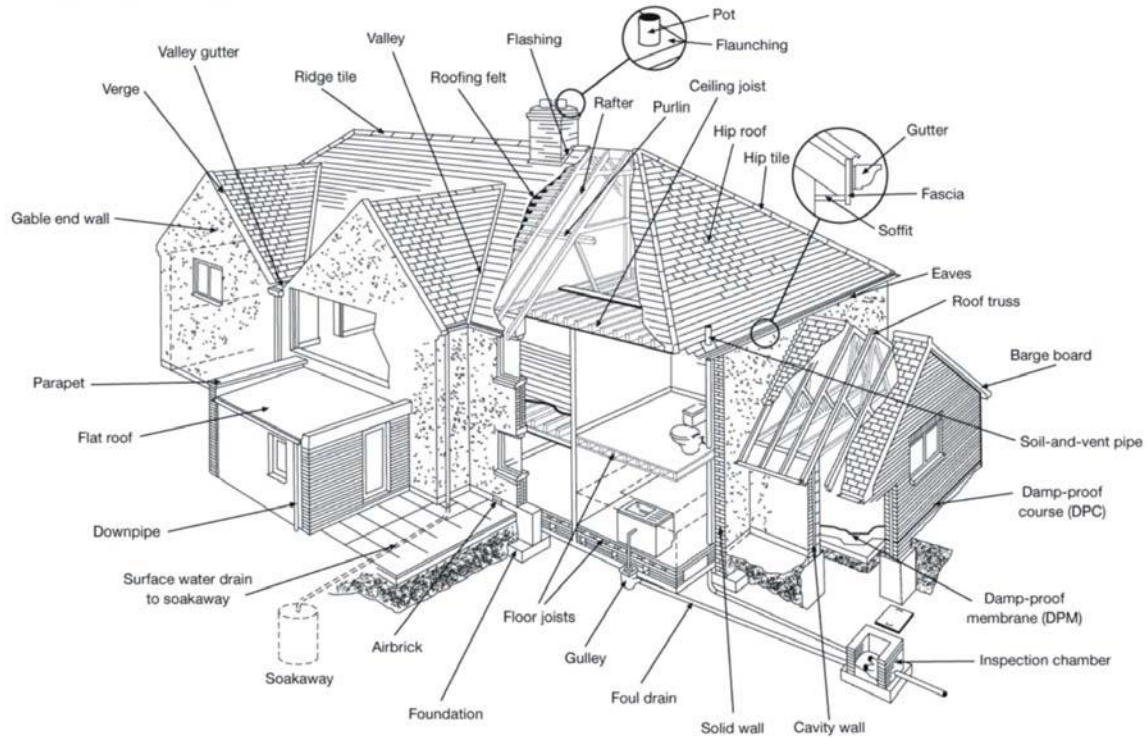
This diagram illustrates where you may find some of the building elements referred to in the report.
